## KOTUKU TRAGEDY HIGHLIGHTS DECAYING FLEET

The fishing vessel *Kotuku* was subject to safety inspections for all but the first three years of her 43-year life, but problems were not picked up, the Transport Accident Investigation Commission said in its report following her total loss on May 13, 2006.

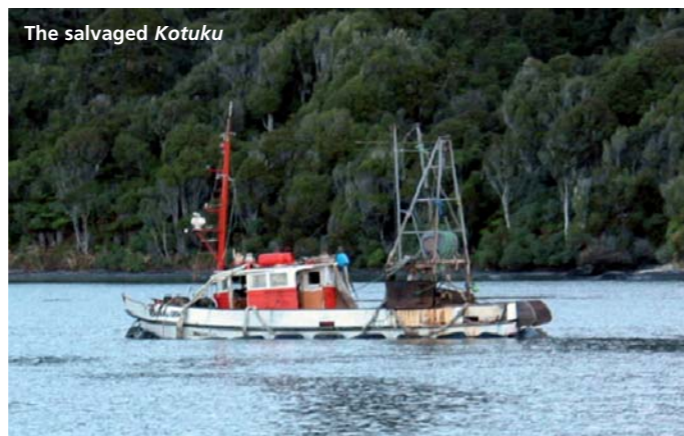
- identified the deterioration of the hull fastenings
- identified or noted the saturation of the hull
- identified that the freeing ports and bulwarks did not comply with the maritime rules
- required that the stability test be completed
- noted that a freeboard (minimum height of the deck above sea) had not been assigned, or
- identified the improper installation of the liferaft," the report said.

The most likely cause of the loss of the *Kotuku* off Stewart Island was having entrapped water on deck at the same time as she was rolled by an unexpectedly steep and high wave, the Commission said.

Factors that could have contributed to the destabilisation included heel due to helm, water in the hull and shifting cargo during the unexpected roll. The freeboard at the transom was estimated to be less than 500mm, and consequently the heel necessary for the deck edge near the stern to become immersed was small.

The salvaged *Kotuku*
