## COLLISION REVEALS AIS VALUE

On a foggy morning on April 28 this year, the coastal ship *Anatoki* was approaching Tauranga Harbour when it collided with *Lodestar Forest*, a bulk carrier. *Lodestar Forest* was departing after disembarking its pilot but, when the accident occurred, both ships were within the compulsory pilotage area for the port of Tauranga.

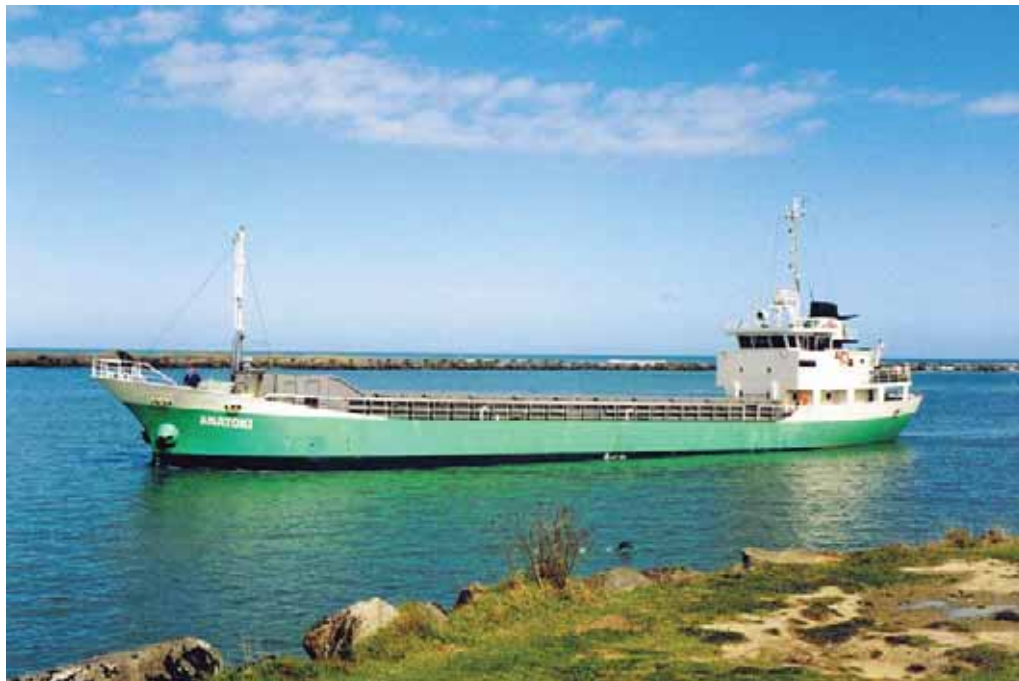
There were no injuries and some minor damage to both vessels did not affect the watertight integrity of either.

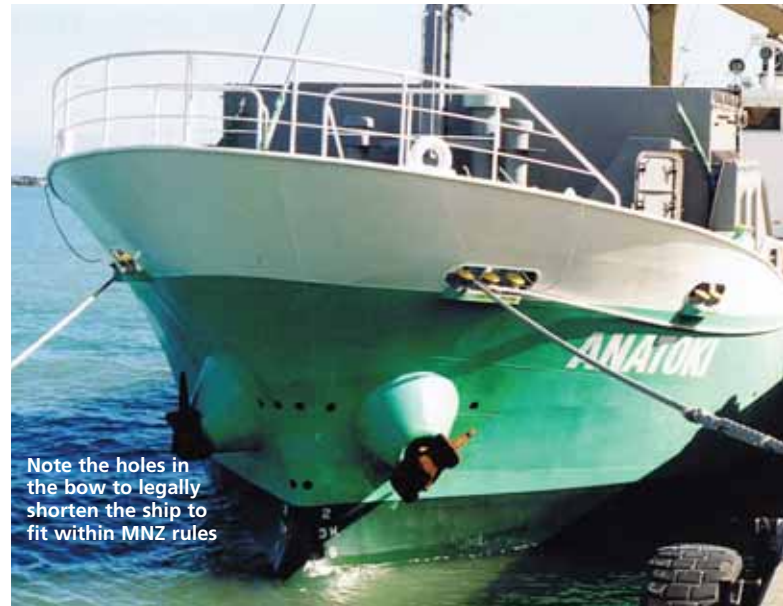
"The naval architect designed a modification that consisted of a free-flowing, open-to-the-sea compartment," the report noted. "The free flooding was achieved by holes cut into the existing compartment both at the top and bottom to prevent pressurisation when the bow went into a wave."

In respect of the bow modification issue the investigator

said the change did allow for the ship to trade in New Zealand waters under SSM, “however, this also had the effect of putting the vessel below the length that required it to be fitted with an AIS installation, thus increasing the risk of incorrect identification of the vessel and its intentions.”
