## CELLPHONE AND SPEED BLAMED FOR FATAL ACCIDENT

**D**istracted by cellphone and excessive speed were found to be the major factors contributing to the fatal collision of the six metre workboat, *Shikari*, with the stern of the moored 27 metre private vessel, *Flightless*.

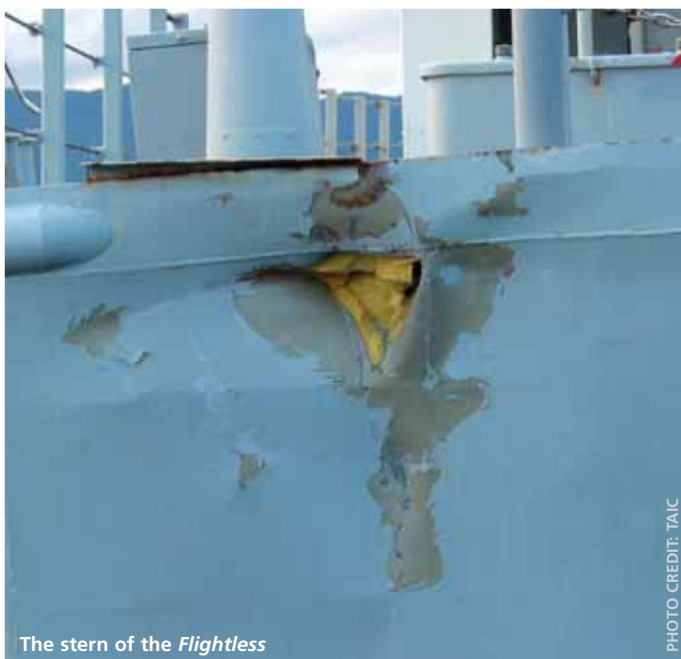
The stern of the *Flightless*

When the accident happened, *Shikari's* impact was sufficient to force the *Flightless* forward on its mooring and to rotate it about its mooring, under power of the outboard motor that was still operating at the time.

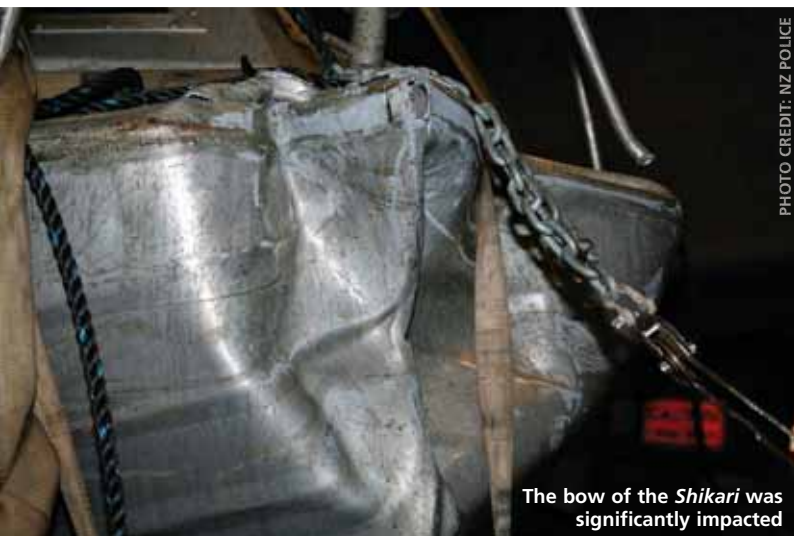
The resulting impact was so strong that the bow of *Shikari* was shortened by around 300mm to 400mm. Dive bottles stored in the back of the boat broke free of their restraints and some were hurled into the water. The helm station, associated hydraulic steering equipment and electronic instrumentation attached to the helm station were also significantly damaged.

The bow of the *Shikari* was significantly impacted
