## SLACK SAFETY STANDARDS LEAD TO BOSUN'S DEATH

Poor adherence to safety standards on the stern trawler *Pantas No. 1* led to the death of the bosun from injuries sustained while directing hatch operations, the Transport Accident Investigation Commission said in its report on the accident.

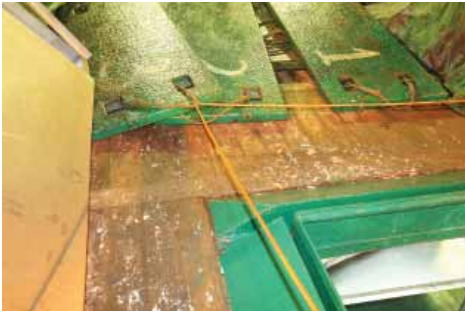
However, as he hoisted the net, the safety rope caught on the bottom of the pallet. As the load rose, so did the safety line, drawing the line initially taut, then pulling it through the loop of the main trawl net. As the "safety" line was pulled upwards on the port side, the movable hatch board was drawn towards the hatch opening, resulting in the safety line being drawn under tension over the hatch opening.

As the load was swung out over the side of the ship the safety line dragged the movable hatch board over the opening, and as

The safety line looped around the hatch board

the load was lowered onto the quay the hatch board was left suspended by the safety line in the hatch opening above the bosun, who was lying unconscious at the bottom of the hold.

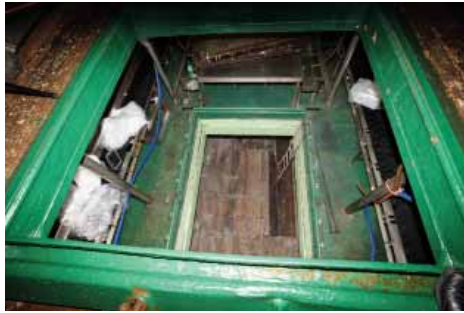
One of the two stevedores on the quay noticed the safety line had caught on the pallet and shouted a warning, which was either not heard or not understood. As the line tightened, it lifted up from the deck behind the bosun, a 52-year-old South Korean, who was crouching inside it, and caught him behind the legs under the buttocks, toppling him into the freezer hold.

Looking down the hatch where the bosun fell

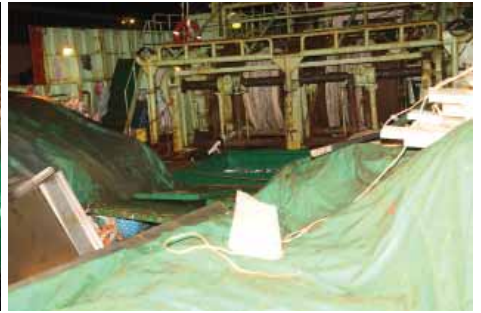
The winch man was normally able to see both the hatch opening and the wharf but not into the No. 3 freezer hold. In this case his vision was partially obscured by equipment and nets.

View from the winch man's position

In its analysis of the accident, the Commission said the winch man's view of the hatch opening was partially obscured by a trawl net and other equipment stowed on deck. So the bosun was using whistles as well as hand and arm signals to direct the winch man until the load was in the winch man's full view.
