OCEAN PIPELINE RIB WAS NOT FIT FOR PURPOSE

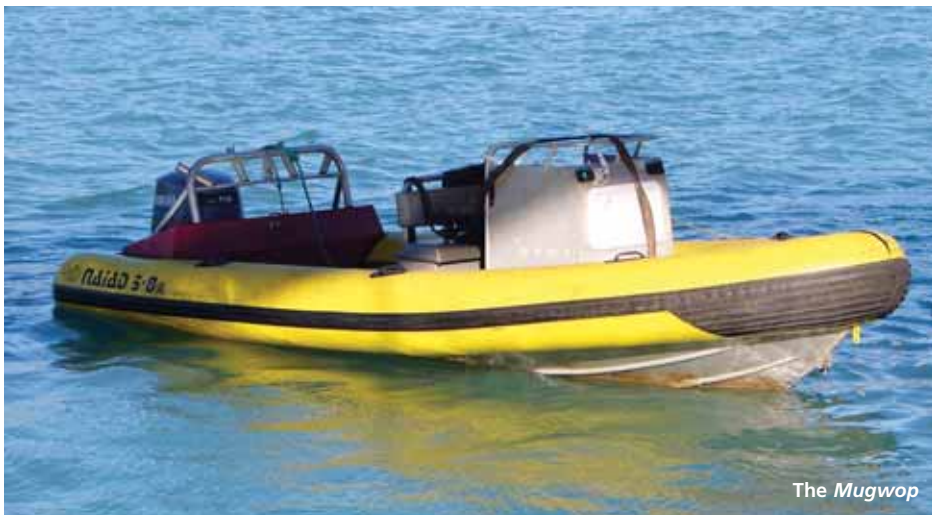
Survey Nelson determined the *Mugwop* did not require a full survey to bring her into safe ship management

The *Mugwop* was constructed of 3mm aluminium with a single inflatable pontoon along each side, rather than the usual two as required under the maritime rules. She had no bilge pump and water drained out through two "duckbills" fitted to the transom.

At the time of the accident there were 4 defects that made the *Mugwop* more vulnerable to catastrophic failure of its inflatable pontoons and sinking:

- the hull was leaking and almost certainly contained a significant quantity of water in its void space
- the outboard motor could not be trimmed to achieve a bow-high trim
- the inflatable pontoons did not have the required subdivision in the inner tubes
- the securing tag for the pontoons at the bow was not fastened to the hull.
