THE TERRIBLE TOREDO

BY MICHAEL PIGNÉGUY

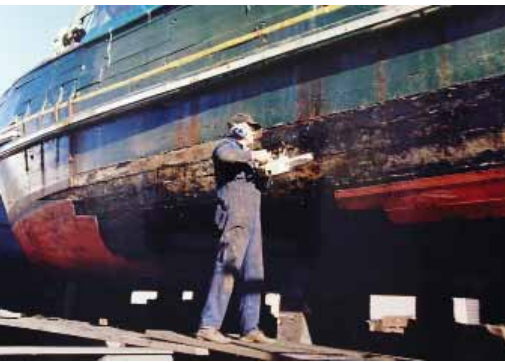
About to start chasing the toredo with my favourite chainsaw!

Attacking a 10in x 4in worm-holed plank with a hammer and chisel proved to be labour-intensive and expensive, especially on a boat with an 86ft waterline and a 25ft beam! If a plank looked like it was home to a few worms, out came the chainsaw and parts of the plank were cut out in seconds, giving us the most expensive firewood in the street!

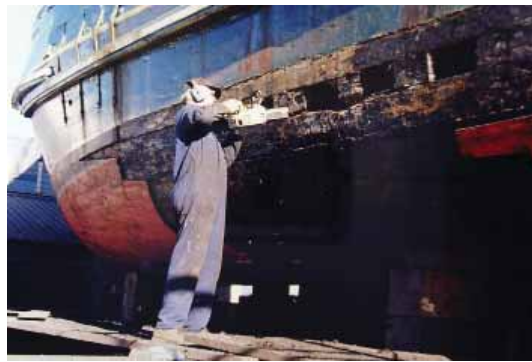
Giving the toredia a hell of a fright as I cut into the 10in x 3in kauri planking

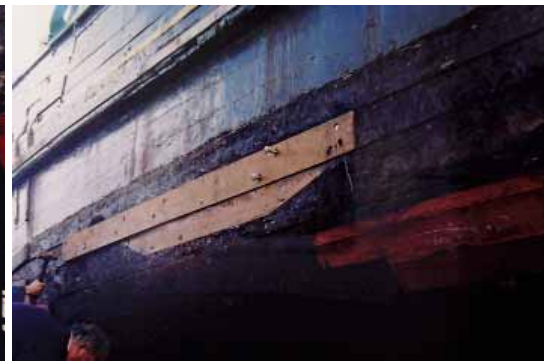
The hole filled with new planks of macrocarpa

As kauri is no longer available we used macrocarpa, totara or even "marinised" pine to replace damaged planks. All the planks then had to be cleaned right back and any poor caulking between each plank raked out.

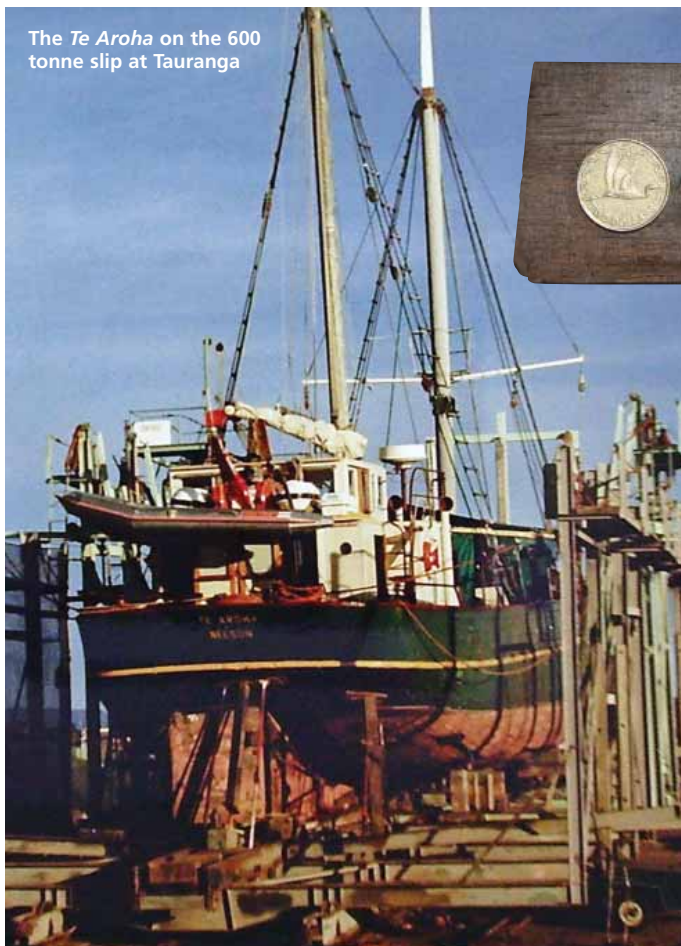
The *Te Aroha* on the 600 tonne slip at Tauranga

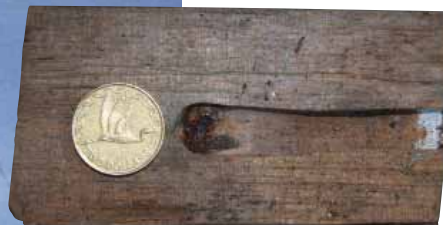
Plank and coin gives an indication of the size of hole these critters chew

Some planks would be completely honeycombed, while others would only show one worm tunnel. Each tunnel had a calcareous lining the worm had secreted for its protection. Observing this practice gave the French engineer Marc Brunel the idea of how to safely construct tunnels for the London Underground. I rarely found any worms in the act of eating our boat, but one I did was as thick as my little finger, about 320mm in length and a fearsome sight indeed!
