## KOTUKU TRAGEDY HIGHLIGHTS DECAYING FLEET

The fishing vessel *Kotuku* was subject to safety inspections for all but the first three years of her 43-year life, but problems were not picked up, the Transport Accident Investigation Commission said in its report following her total loss on May 13, 2006.

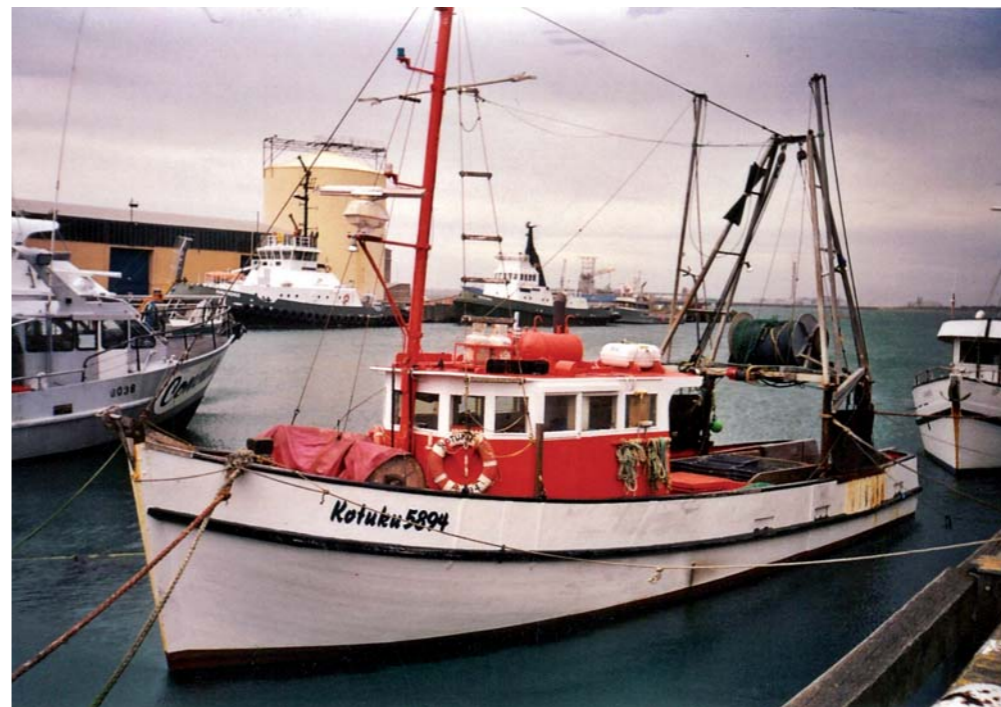
Between 1415 and 1430 when they were off the northwestern corner of North Island, two larger than average waves reportedly struck the *Kotuku's* port side. The first caused her to roll heavily to starboard with sufficient momentum to shift unsecured items in the cabin. She recovered, righted herself and rolled heavily to port.

The second wave rolled her again to starboard, but this time she rolled smoothly and continuously until she capsized, coming to rest fully inverted. During the last roll to starboard, the deckhand,

who was on deck, said that something was wrong and that fish cases were floating off the deck.

The owner and his friend used a floating fadge to support them. The other survivors climbed onto the upturned hull. The bulwarks and pond boards appeared to have prevented other buoyant debris from floating clear until she eventually sank.
