## SLACK SAFETY STANDARDS LEAD TO BOSUN'S DEATH

Poor adherence to safety standards on the stern trawler *Pantas No. 1* led to the death of the bosun from injuries sustained while directing hatch operations, the Transport Accident Investigation Commission said in its report on the accident.

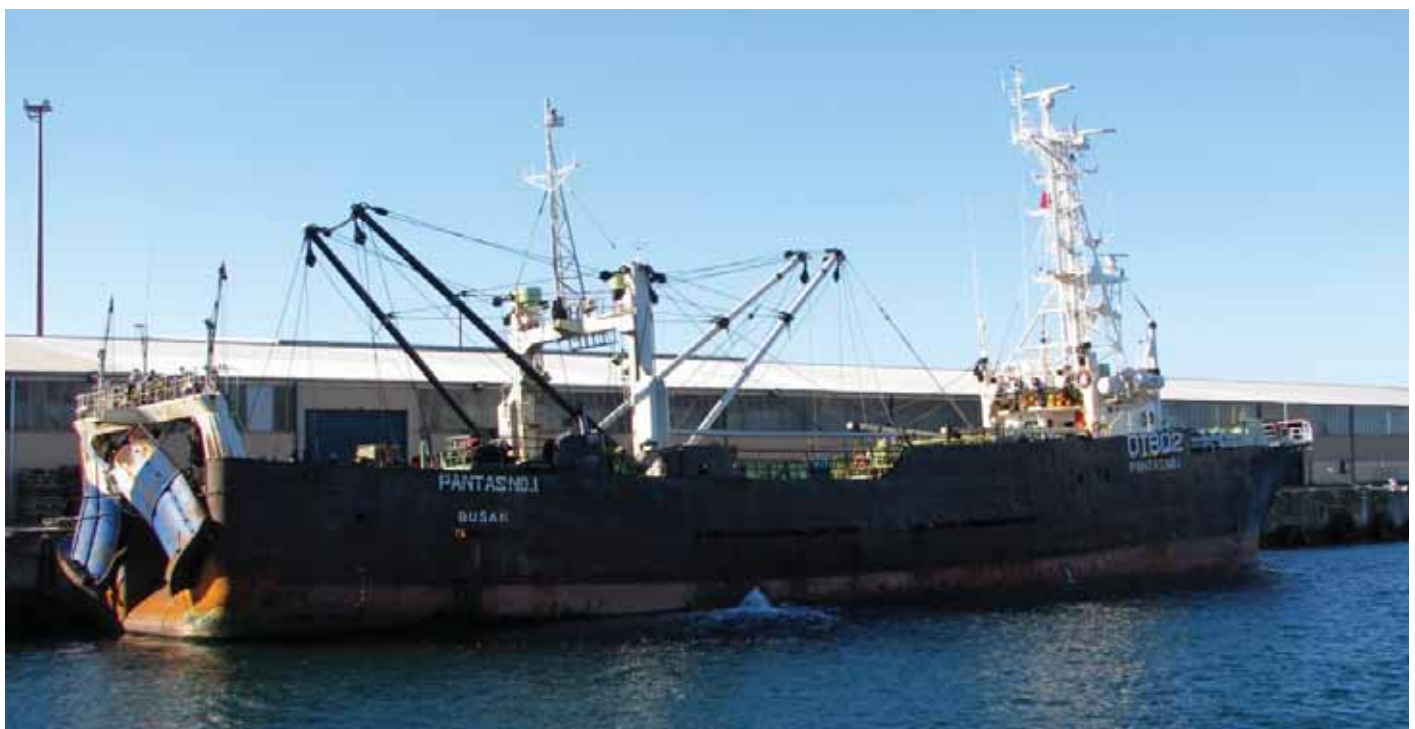
One of the two stevedores on the quay noticed the safety line had caught on the pallet and shouted a warning, which was either not heard or not understood. As the line tightened, it lifted up from the deck behind the bosun, a 52-year-old South Korean, who was crouching inside it, and caught him behind the legs under the buttocks, toppling him into the freezer hold.

As the load was swung out over the side of the ship the safety line dragged the movable hatch board over the opening, and as

the load was lowered onto the quay the hatch board was left suspended by the safety line in the hatch opening above the bosun, who was lying unconscious at the bottom of the hold.
