# GREAT SHIP – pity about the fubar\*

BY KEITH INGRAM

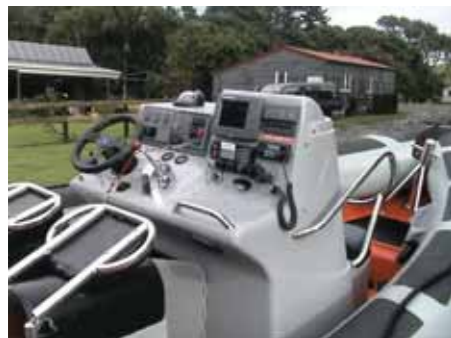
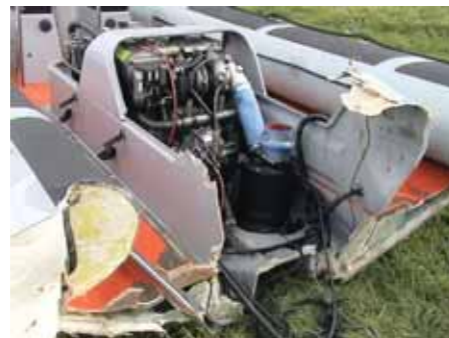
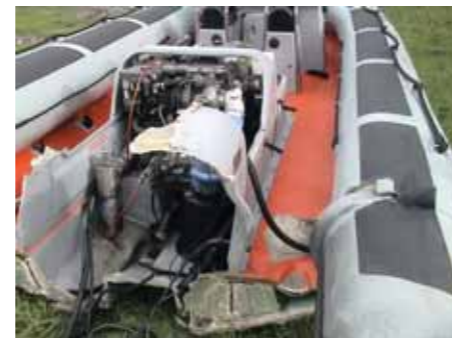
When the RHIB was ripped out of her secure cradle and davits, the transom and jet unit was left hanging in the ship

Except that on this occasion, while crossing the Bay of Plenty, she lost three-quarters of one of her two seaboats, with only the transom and the jet unit remaining in the after falls and the for'ard lifting point in the for'ard falls. She was physically ripped out of her secure boat station, where she was securely held down by what I would estimate to be five-tonne webbing straps.

In the middle, lashed in its sling and chocks, is about a 7.5m RHIB. Essentially it is a cork, and when any reasonable seas are taken anywhere from the shoulder to the quarter, there is a high probability that these waves will break into this seaboat opening.

Now you start to get the idea. When 40 tonnes of solid water is being driven into a hole in the hull in which a very buoyant boat is lashed, something is going to give. On this occasion, our wayward vessel drifted up onto the back of Great Barrier Island, at Whangapoua, after floating across the Bay of Plenty.

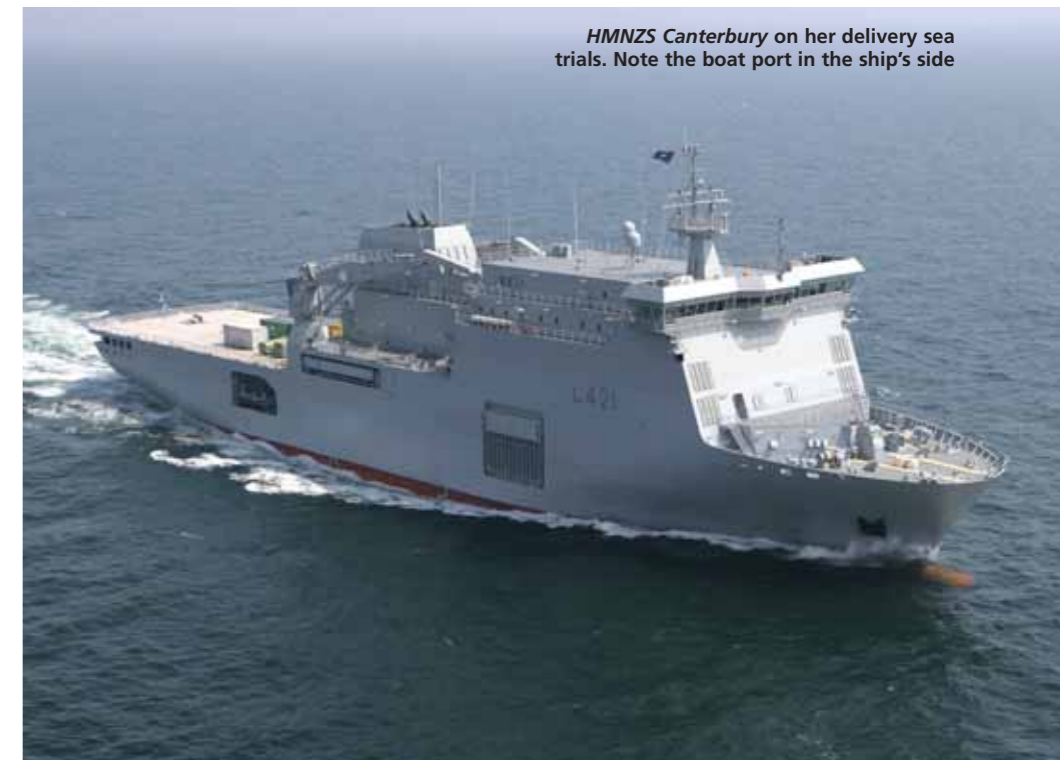
HMNZS Canterbury on her delivery sea trials. Note the boat port in the ship's side

So just what is wrong. Essentially, we have a hole on either side of the ship about the size of a 40ft container, give or take a bit.

Doors have been suggested, but if these are not constructed properly, as in stern doors, or ship's side-loading doors, the problem of sea damage buckling the doors and making them inoperable is a real risk. But then superyachts have doors that seal, so this might work. Wave-break doors are another option but these are high maintenance and prone to failure.
