GROUNDING COULD HAVE BEEN AVOIDED

Fishing charter vessel, *Pursuit*, with five passengers and two crew aboard, was lying at anchor when it grounded on rocks close to its anchored position.

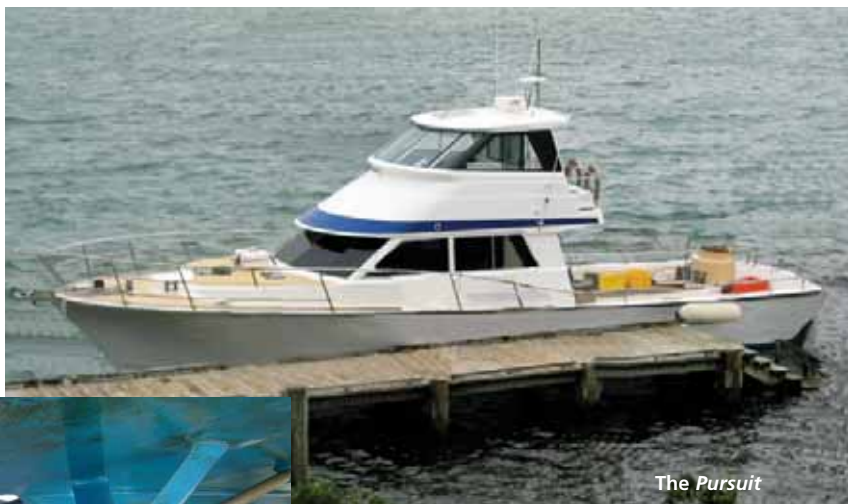
The Pursuit

Pursuit, which is owned by White Island Marine Charters, was later towed off the rocks by another vessel. There were no injuries to passengers or crew but *Pursuit* sustained considerable damage to its hull, drive train and steering.
